# *the* Inspection Reporter

Ronald D. Scott, P.E.

## Common Issues in the Evaluation of Houston Homes Built in the 1950's and 1960's

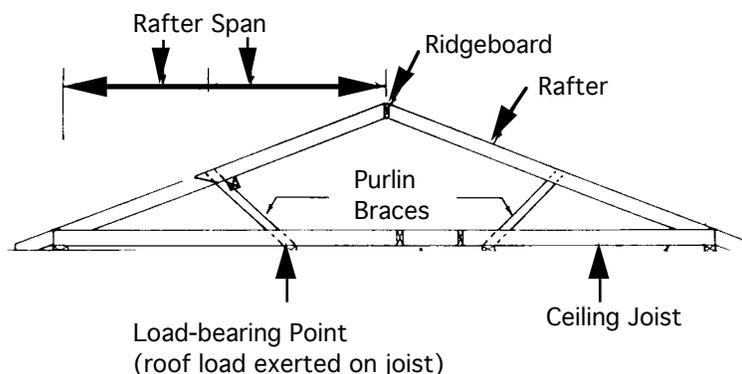
If framing deficiencies have resulted in abnormally unlevel roof surfaces, framing distress (joint separation), or framing defects, then framing modifications or reinforcement will be necessary. See the following schematic drawing for a description of the most common roof framing members.

Some of the more common construction framing deficiencies observed in older homes by this inspector include:

- Excessive rafter spans, resulting in "sagging" roof surface conditions (deflection) visible from a ground-level view; this condition typically requires the addition of purlin support bracing.

- Inadequately designed purlins (horizontal framing supporting the rafters); purlins are required to be at least the dimension of the rafters (i.e., 2"x8" rafters require the use of 2"x8" purlins), and the purlins should be properly supported with "strut-type" braces.

- An inadequate number of nails at the rafter/ridgeboard joint connections (three nails required at face-nailed connections; four nails at "toe-nailed" connections), often resulting in excessive separation at the rafter/ridgeboard framing joints.
